# Internal Memorandum

Subject **DRS Condition Report on Sir John Maxwell School**

A group of officers from DRS Housing & Regeneration Services (surveyors) and Project Management and Design (Structural Engineer) carried out an inspection of the above property on the Tuesday 24th September 2013.

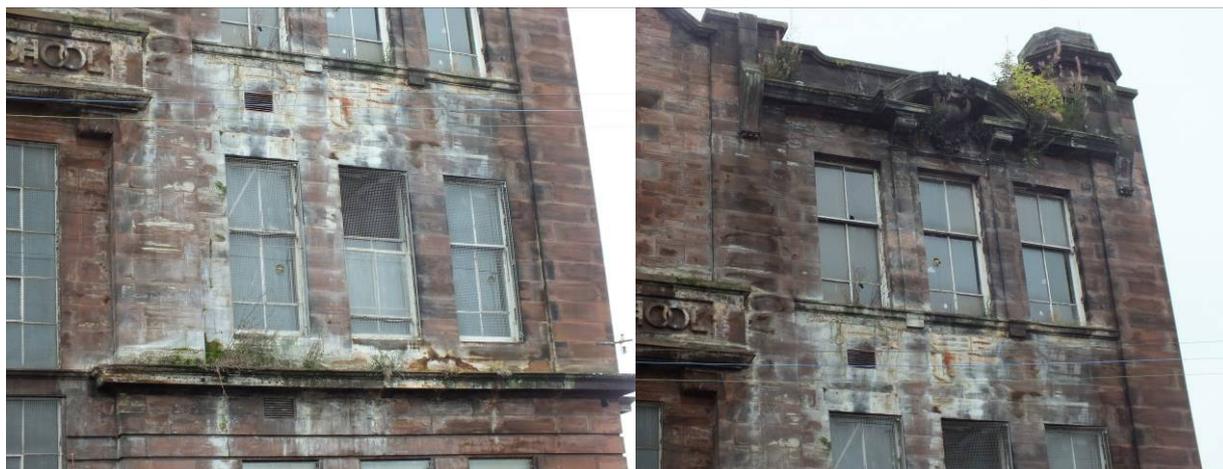
The NE elevation shows substantial signs of dampness and is covered almost in its entirety by white staining that is likely to be efflorescence. It is also possible that the white staining present a degree of fungal infestation on this elevation. However, this will need to be confirmed by a rot specialist who would carry out a full disruptive rot survey. There are also numerous areas of vegetation growth on this elevation which is a symptom of blocked drainage outlets and an overall lack of maintenance.

*NE elevation showing widespread efflorescences and vegetation growth*

Dampness is evident externally on the NE elevation as efflorescence's and vegetation growth are widespread. This elevation is especially on a constant estate of dampness well beyond the acceptable levels.

The remaining elevations are in considerably better condition and show only small localised areas of efflorescence. Again, a rot specialist should confirm the existence of any fungal infestation in all parts of the building, including the external elevations.

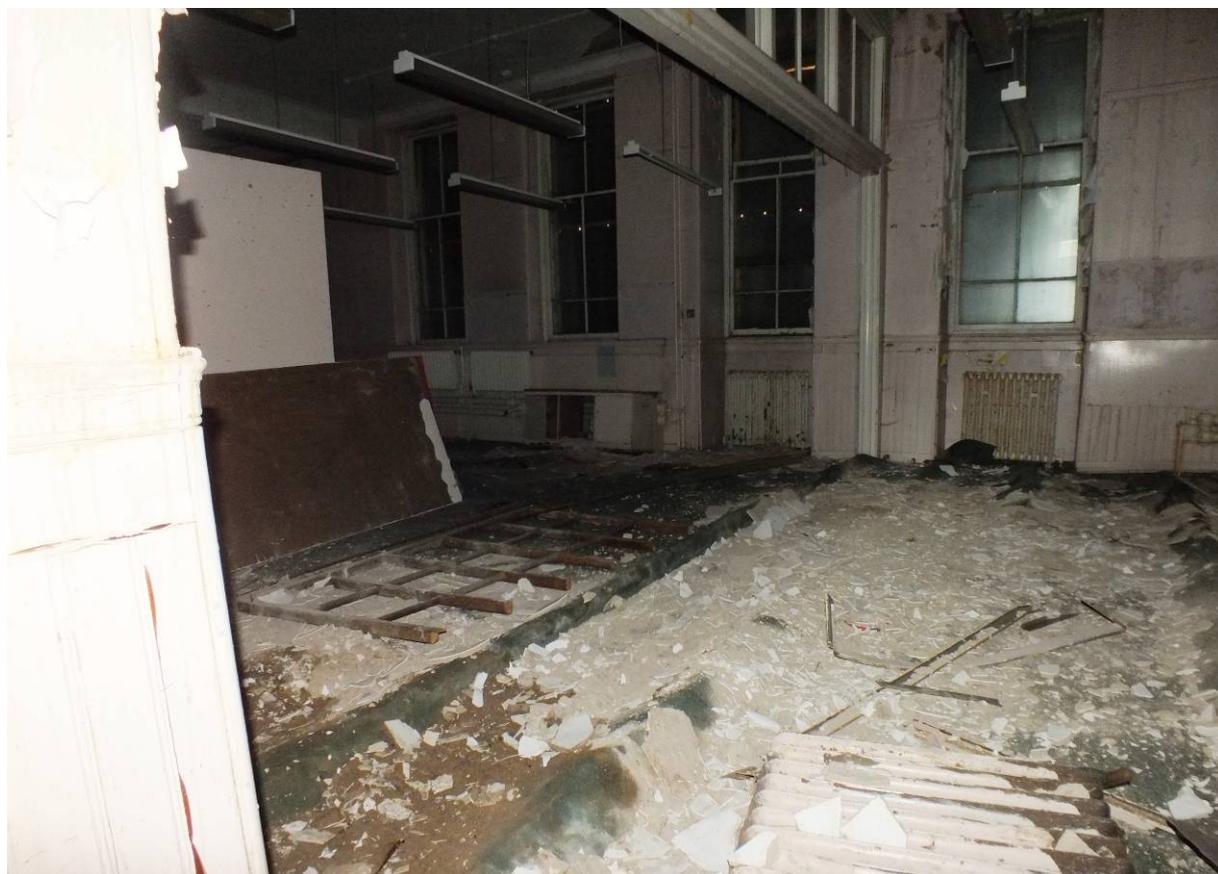
Internally, all areas of the property have been badly affected by water penetration due to the failure of the roof and gutters. Most of the walls, floors and ceilings are in a state of constant water saturation and moisture levels of materials were recorded as maximum in most areas. In fact, moisture levels could not be recorded as they were too high for the damp meter 'Protimeter' device as it was showing levels above the maximum limit.

This has resulted in localised ceiling collapses, floors becoming badly warped and wall finishes deteriorating.

*Interior view of one of the classrooms*

There is a real concern that rot might exist within the majority of the building elements including structural members (walls, floors, ceilings, joists, beams, windows etc.). It is therefore essential that an intrusive rot survey is carried out to determine the extent and type of any rot affecting the building.

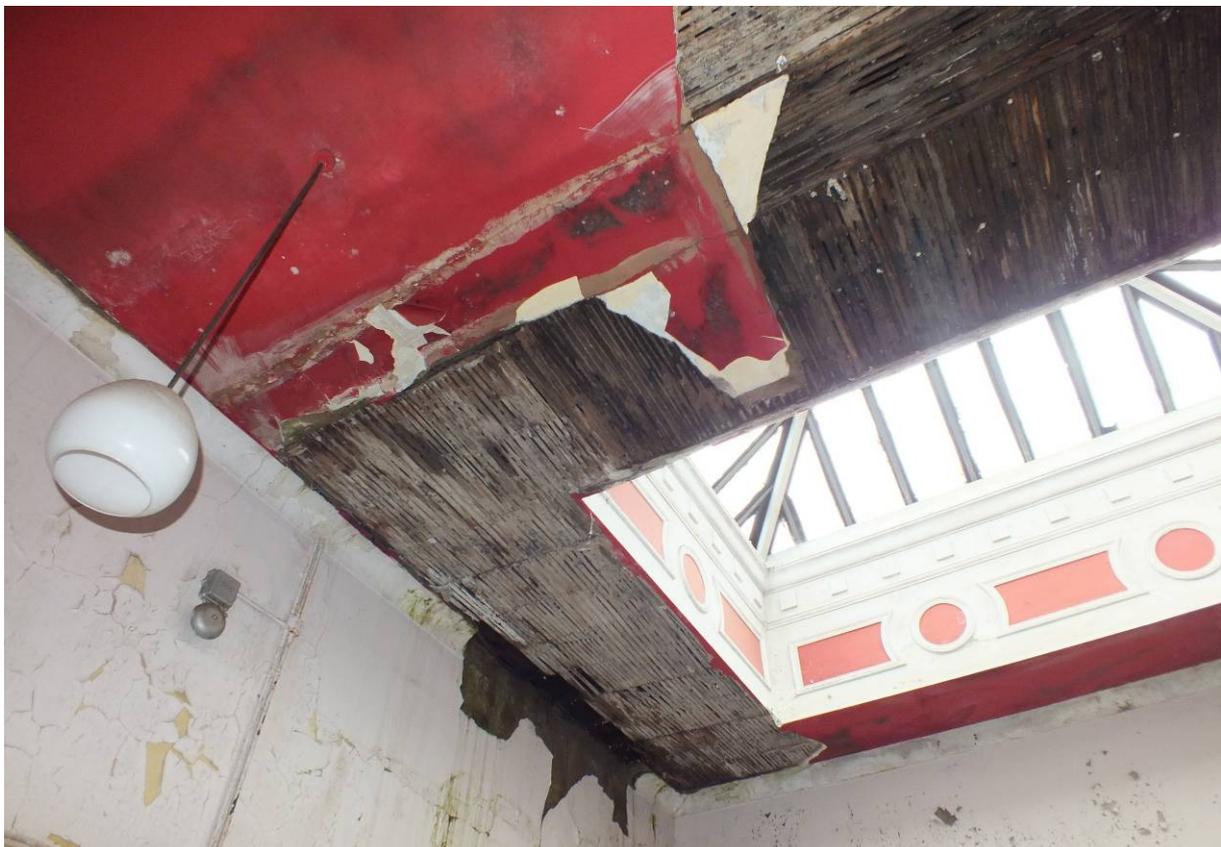
It is likely that the whole roof will need to be replaced as this is causing the majority of the water ingress and appear to be in a very poor condition. It is thought that majority of damage has occurred due to failures of gutters (lead theft was reported) and general lack of maintenance of the roof drainage system. Lower areas of the roof seem to be in poorer condition than the top parts.

*Ceiling collapsed above one of the stairwells*

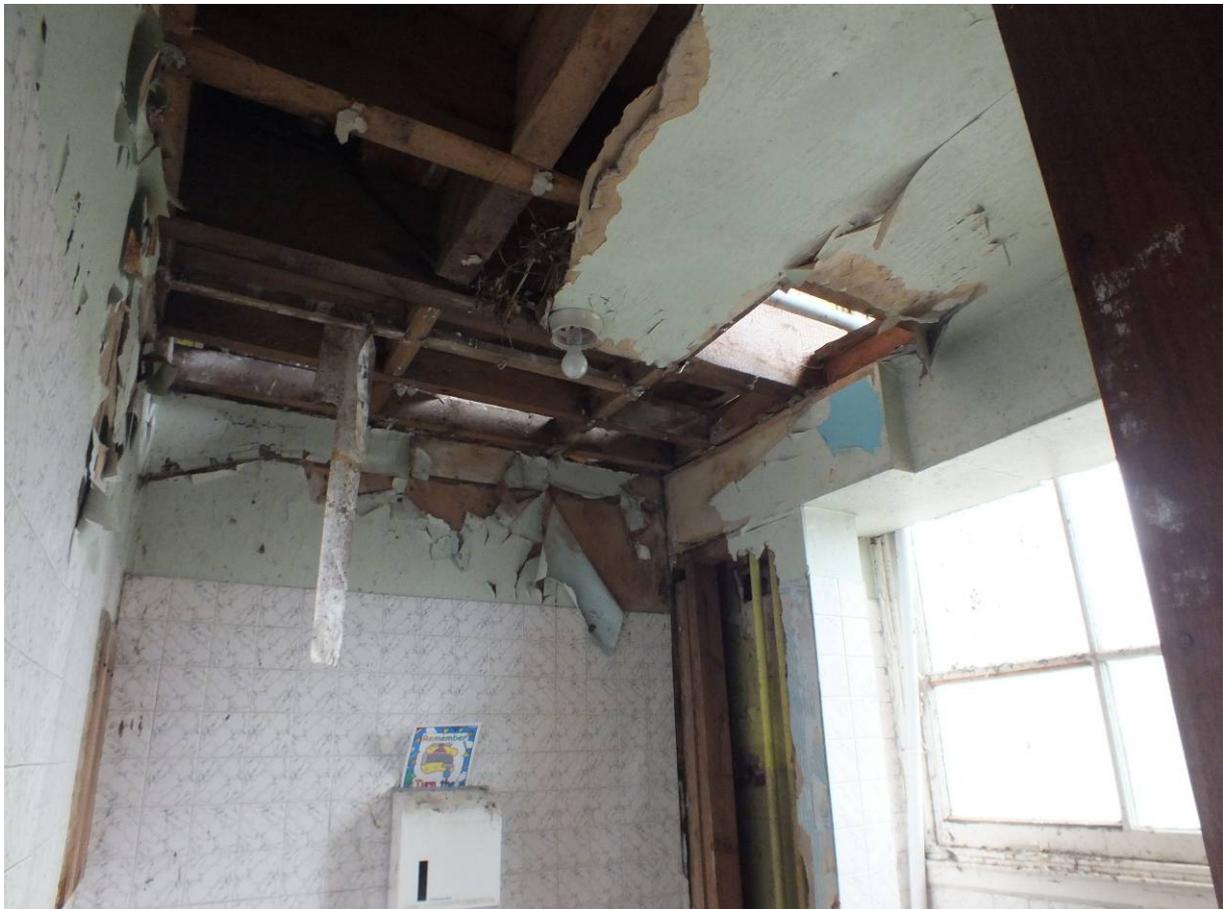
*Ceiling collapsed on a bathroom area*

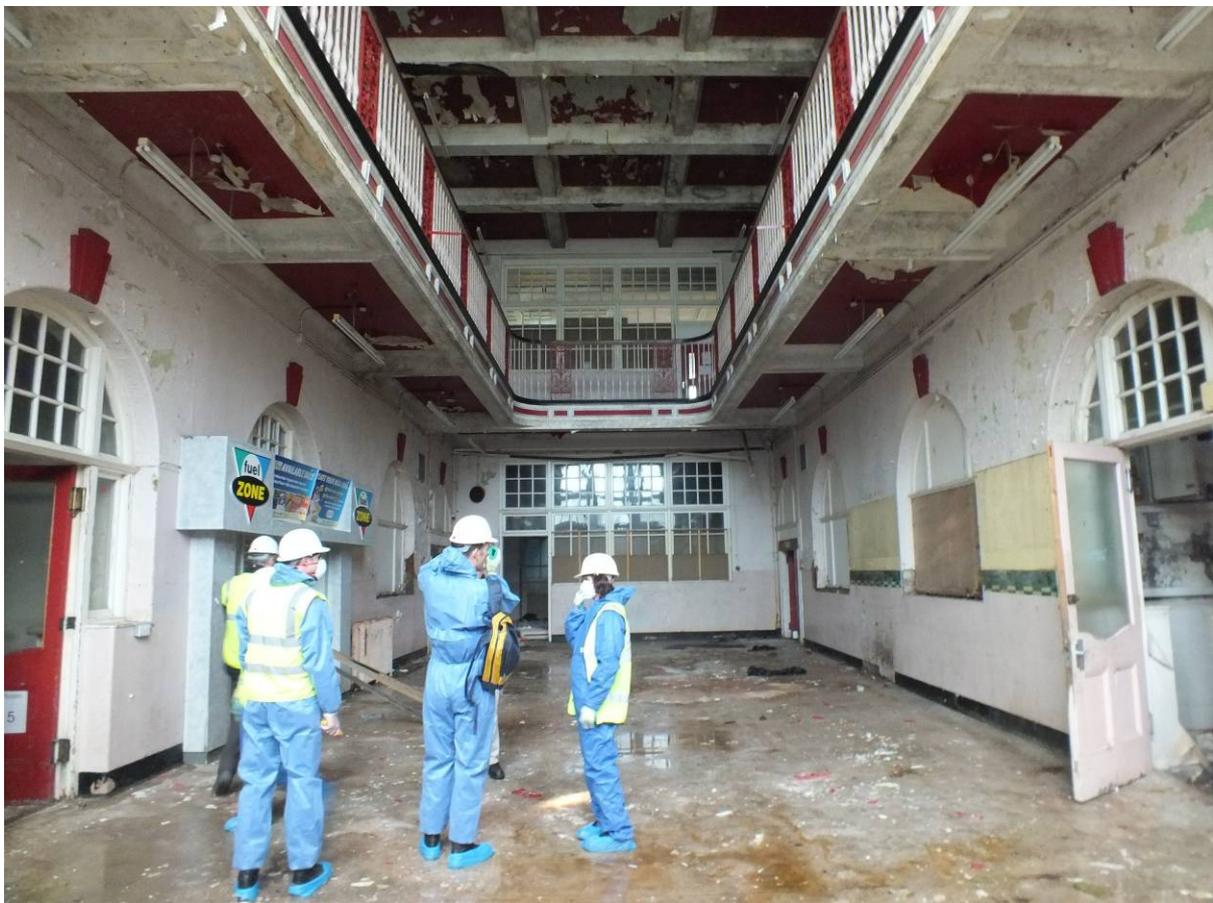
The Sir John Maxwell School presents a bigger footprint with a deeper plan that will make it more difficult to convert into flats. Around 145m<sup>2</sup> of footprint will be difficult to develop as this covers the internal atrium space that would be required as circulation to access flats but will not be able to generate an income for the project. This will pose a very high financial penalty to the project.

*Internal atrium space*
